UPPER MILLPOND DAM
CT 00390

INDIAN RIVER BASIN
CLINTON, CONNECTICUT

PHASE I INSPECTION REPORT
NATIONAL DAM INSPECTION REPORT

January 9, 1981

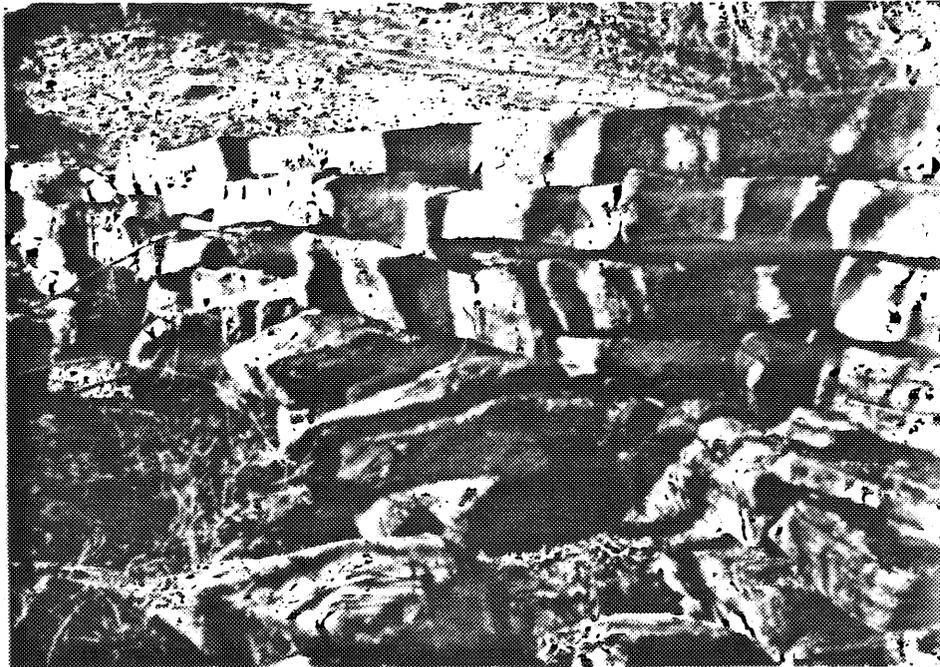
4. Downstream face of dam taken from about Sta 0+50 looking toward right abutment.

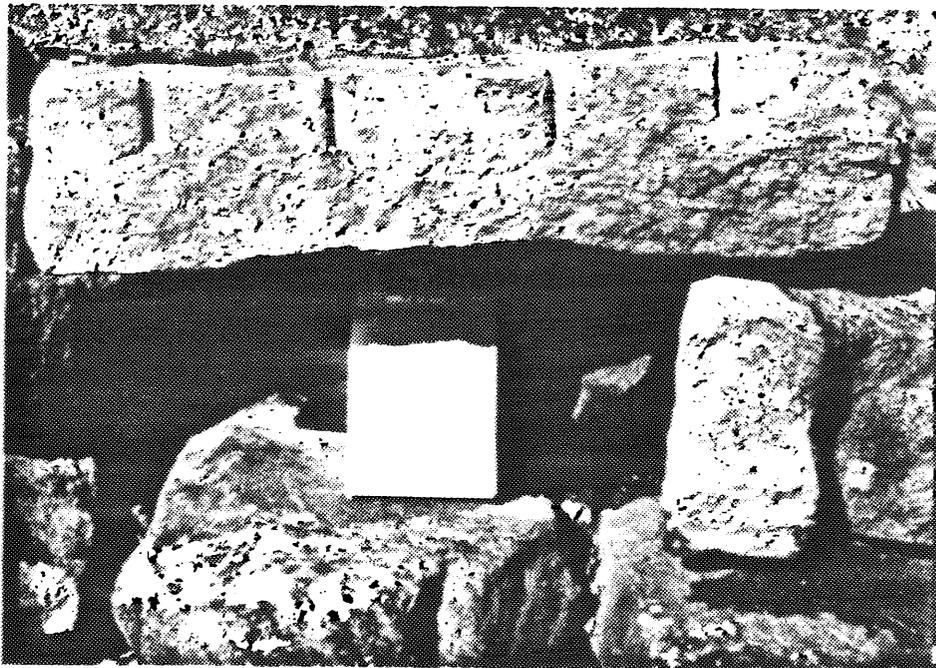
7. Large opening in downstream face of dam at about Sta 0+25. Opening is about 3-ft-wide and 1.5-ft-high and extends about 3 feet into the dam.

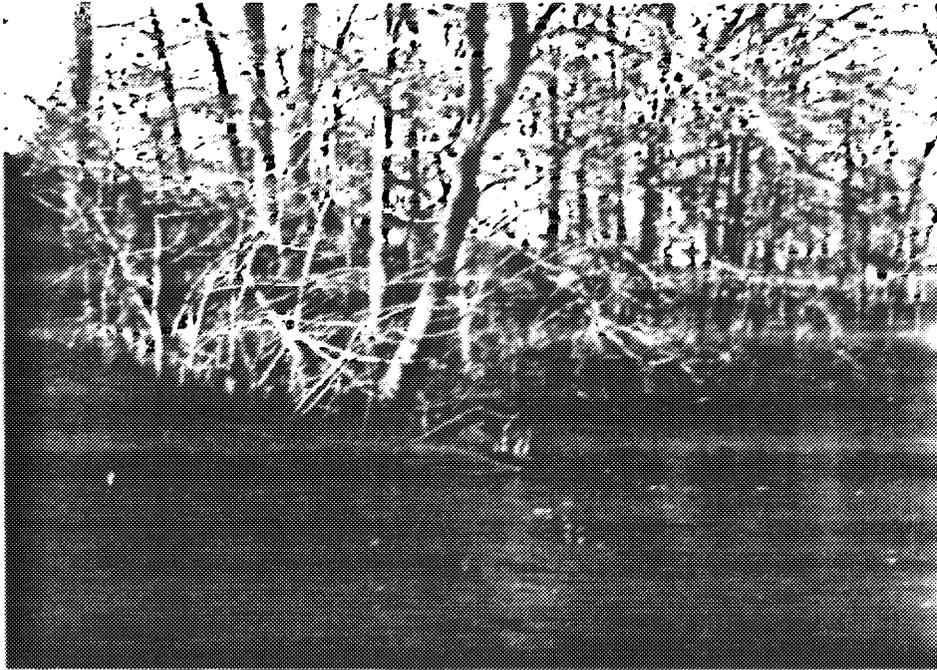
8. Overhanging Tree on Right upstream bank.
